## **Teardown: Inside a 3G MicroCell**

Brian Dipert - June 23, 2015

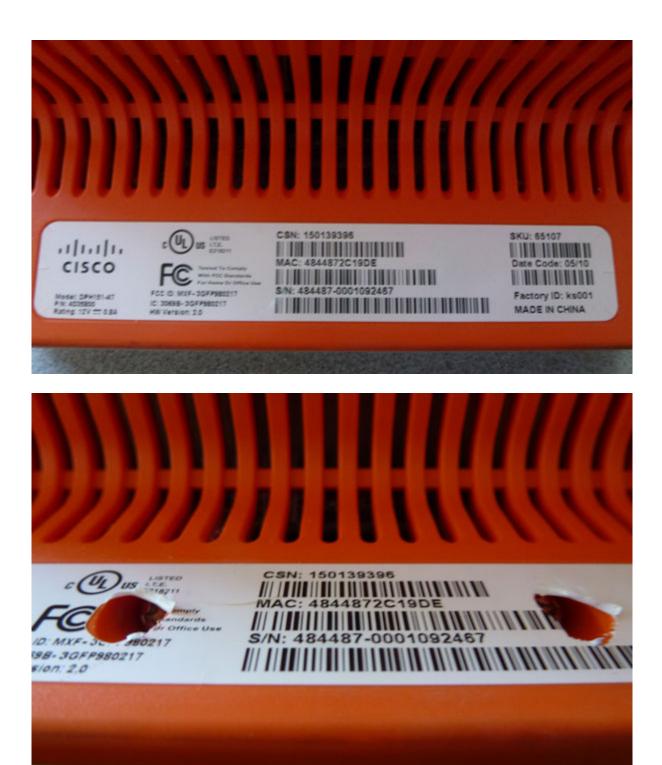
Underneath the under-device information sticker, thumb-presses suggested what were confirmed by subsequent punctures to be two Philips head screws:

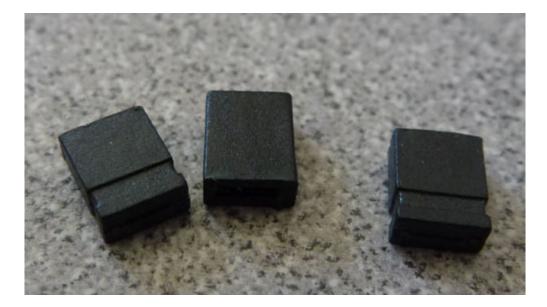
But accompanying the plastic panel, three small jumpers fell out of the unit as well:

I'd already been <u>tipped off to their existence</u>, albeit not their exact location. They're a tamperprevention scheme, albeit somewhat different in implementation than the <u>one documented</u> in an <u>infamously scathing analysis published elsewhere</u>. If they're not present (or alternatively are installed/re-installed) in incorrect positions when the unit is powered up, AT&T tech support is automatically alerted to the device's compromised state. Here are close-ups of the relevant jumper pin and retainer sites on the PCB and side panel:

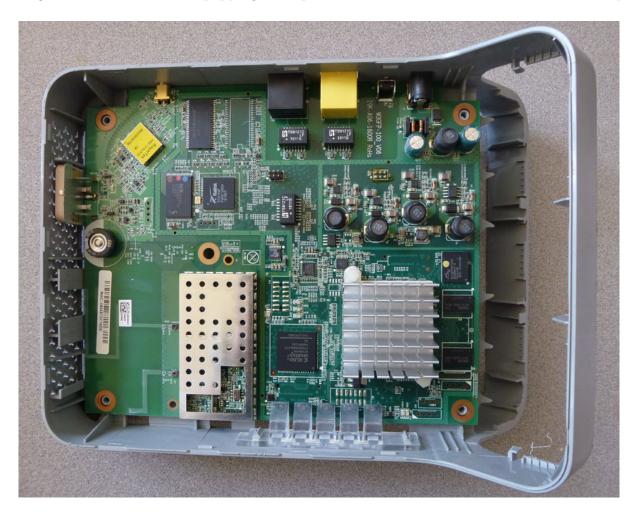
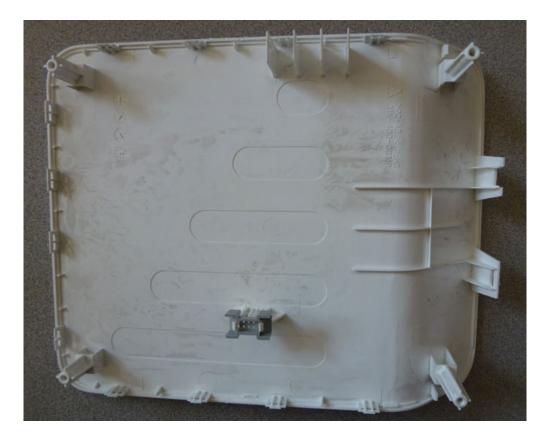
Removing four more screws, and popping more plastic tabs, enabled removal of the other side panel:

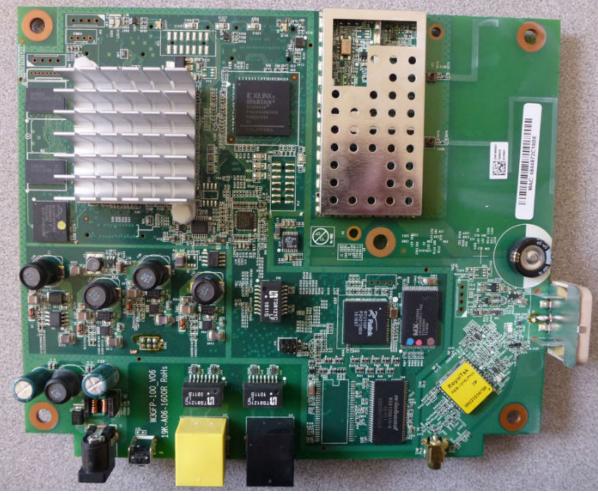
Finally, after a bit more wriggling, the AT&T 3G MicroCell's guts are fully exposed:

Your eye may first be drawn to the large heat sink in the upper left corner, but before we get to that,

let's look first at the memory subsystem ... subsystems, to be exact, because the PCB contains two DRAM-plus-flash clusters. To the left of that heat sink are two Samsung <u>K4T51163QG-HCE6</u> 512Mbit 667MHz DDR2 SDRAMs; below them is a Spansion <u>GL512P10FFCR2</u> 512 Mbit MirrorBit NOR flash memory. Along the bottom edge of the PCB are two IC sites, only one of which is populated by a Winbond <u>W9812G6IH-6</u> 166 MHz 128 Mbit SDRAM. And in its upper right corner is a Macronix <u>29LV320DBTI-70G</u> 32 Mbit NOR flash memory.

Why the seeming redundancy? I suspect it's because the two DRAM-plus-flash memory clusters handle data and code storage functions for two different SoCs. The first, Ralink's RT2150F, is located just to the left of the Macronix flash memory. It <u>doesn't seem to be a standard line item</u> IC, but I suspect it controls the unit's LAN and WAN wired Ethernet ports, as well as managing the routing function between them along with the data flowing between it and the cellular voice-an-data subsystem.

Now for that other mysterious IC below the heatsink. FCC certification report images indicate that it's a picoChip PC203 femotocell SoC, which <u>at-release mid-2008 coverage at EE Times</u> identifies as being "a single-chip solution for HSPA femtocells compliant to TR25.820 and the newly standardized Iuh interface. Supporting up to four users for residential and SME femtocell access points and with data rates of 14.4 / 5.7Mb/s in downlink and uplink respectively the PC302 enables the lowest bill-o--materials and lowest power for a femtocell available today." It was <u>followed by a femtocell reference design</u> a year (and a few months) later; I'd be curious to know how closely the Cisco-developed 3G MicroCell hews to it, if any of you have information. picoChip was <u>subsequently acquired by Mindspeed Technologies</u> in early 2012.

To the right of the picoChip PC203 is a <u>Xilinx XC3S400A Spartan-3A FPGA</u> (PDF), whose exact functions in the system are unknown (because, duh, it's user-programmable) but likely handles various high-speed signal processing tasks in partnership with the SoC next door. And next to the FPGA is the cellular radio analog subsystem, underneath a Faraday cage. Prying the top off it, and further moving to the side a secondary metal slice, reveals what's inside:

Speaking of receivers, where's the GPS subsystem? The bright yellow-labeled IC in the bottom right corner of the PCB is <u>RoyalTek's REB-1315LPNX</u> (PDF) single-chip digital-plus-RF GPS receiver. To the right of it is the femtocell's integrated GPS antenna, and below it is the connector for the optional (and included) external cable-tethered GPS antenna, in case you're unable to obtain GPS "lock" at your preferred femtocell location.

And speaking of connectors, I'll close out the discussion of the PCB top-side with a left-to-right revelation of the remainder of the bottom-edge residents: power connector, hard reset switch, WAN Ethernet port (labeled "Ethernet"), and LAN Ethernet port (labeled "Computer"). Use of the latter is only necessary (and wasn't in my case) if firewall restrictions preclude you from putting the 3G MicroCell behind your network's normal router. Then again, in this case your LAN would become double-NAT'd as a result, which causes all sorts of problems of its own ... above the Ethernet connectors are the corresponding transformers.

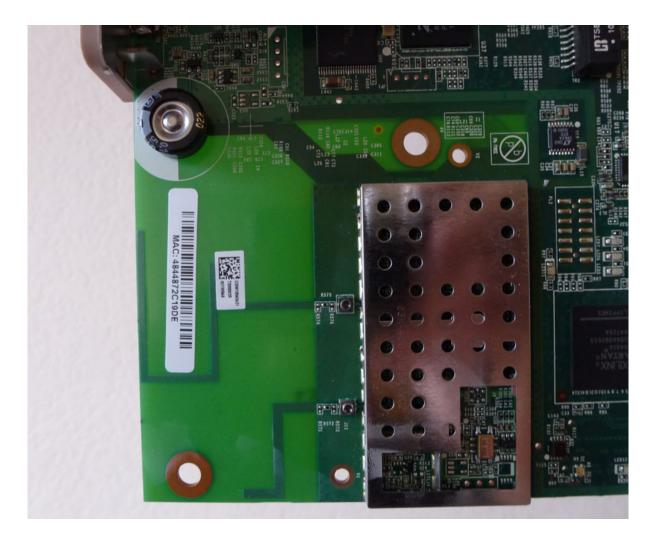
Speaking of antennas, where's the cellular aerial? I suspect it's built directly into the PCB (readers: agree or disagree?). Shining light through the circuit board makes it more visible:

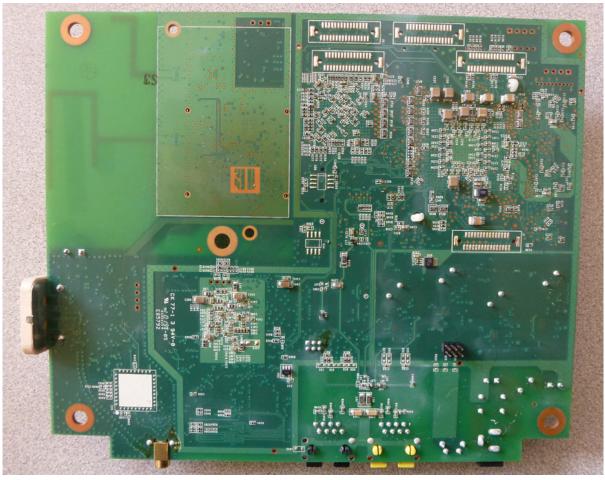
Finally, let's take a peek at the PCB backside:

Not much to see, aside from the aforementioned tamper-detection jumper pin block, a few rows of what I presume are test points, and some chip-clustered passives.
